# Manhole Inspection Summary

Manhole # **S17C\_\_032MH**

**Location** Address: **BEHIND 2444 EDMONDSON AVE** Cross Street: **N WARWICK AVE**

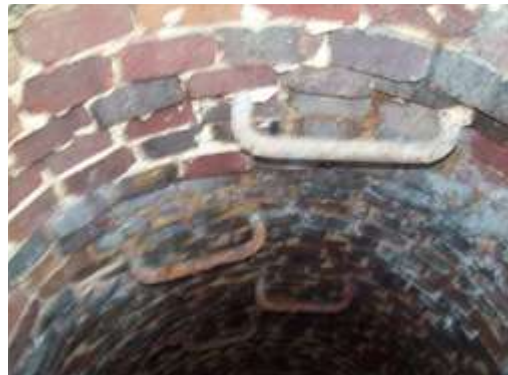
Defect 2

**Steps** Count: **5** Missing: **0** ☒ **Corroded**

CORRODED STEPS

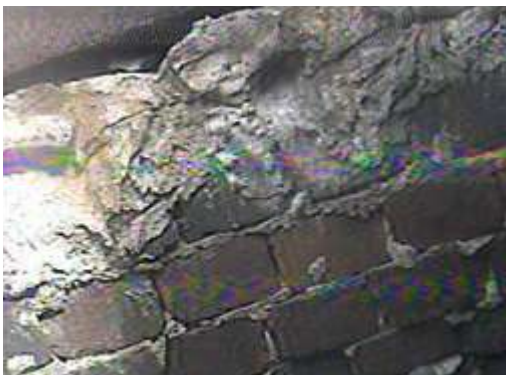
Defect 1

**Chimney / Frame Adjustment** ☒ Exists Material: **Brick** ☐ Parged Height: **8** (in.)

Condition: ☐ Sound ☐ Cracked ☐ Root Intrusion ☐ Loose Brick ☒ **Deteriorated**

DETERIORATED CHIMNEY

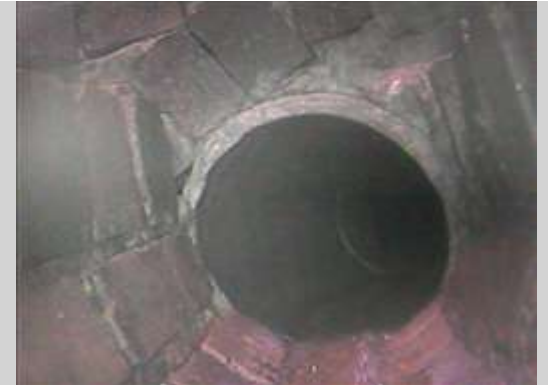
12 O'Clock Outflow

8 in. Circular Gravity Sewer  
Pipe Out @ 12 O'Clock

Pipe Material: **Clay** ☐ Pipe Lined

Invert Depth: **9.20** (ft.) Flow Characteristics: **Slow**

Infiltration: **None** Pipe Seal Cond: **Sound**

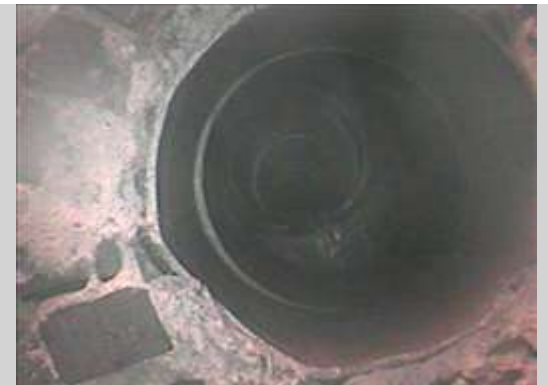
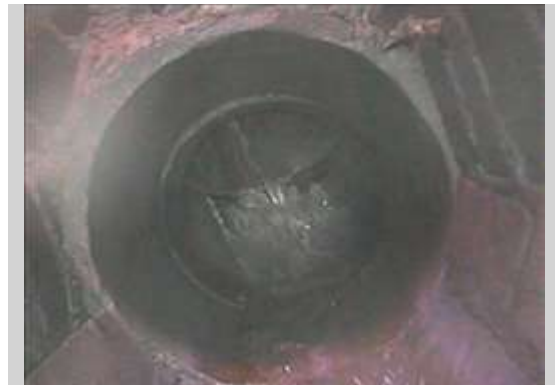
6 O'Clock Inflow

10 in. Circular Gravity Sewer  
Pipe In @ 6 O'Clock

Drop In @ 6 O'Clock

Drop: **Outside Direct**

Drop Condition: **Open**
